Heritage (Decision about Registration of Robertsons' House, Oaks Estate) Notice 2015

AUSTRALIAN CAPITAL TERRITORY
HERITAGE REGISTER
(Registration)

Robertsons' House

Robertsons' House, 9 Hazel Street. Blocks 11-12 Section 7, Oaks Estate

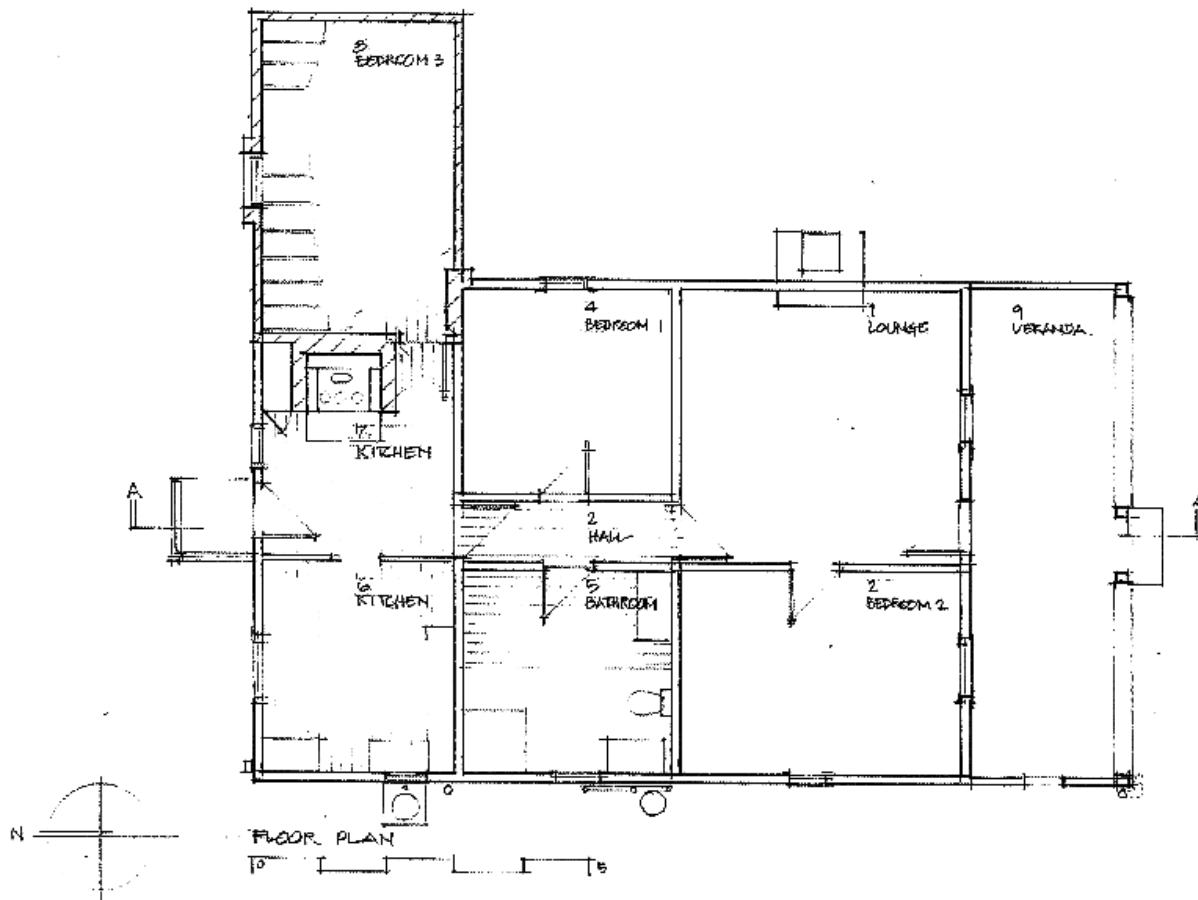
Figure 1 Robertsons' House measured drawing (Philip Leeson Architects, 2007. p.5)

Robertsons' House is a three bedroom L-shaped house with an internal bathroom, a lounge room with a wood fire heater, a kitchen with a partition through the centre and a wood fire stove, a verandah on the southern end, and several outbuildings connected to the house by paths and paving (see Figure 1 for floor plan and room numbers). The main house has been built in several stages with various materials which is evident based on exposed material as well as design, both internally and externally. The house and outbuildings are located on a long parcel of land, ~90m north south by 20m east-west, comprising Blocks 11 and 12 Section 7 (originally they were a single block, Block 7 section G).

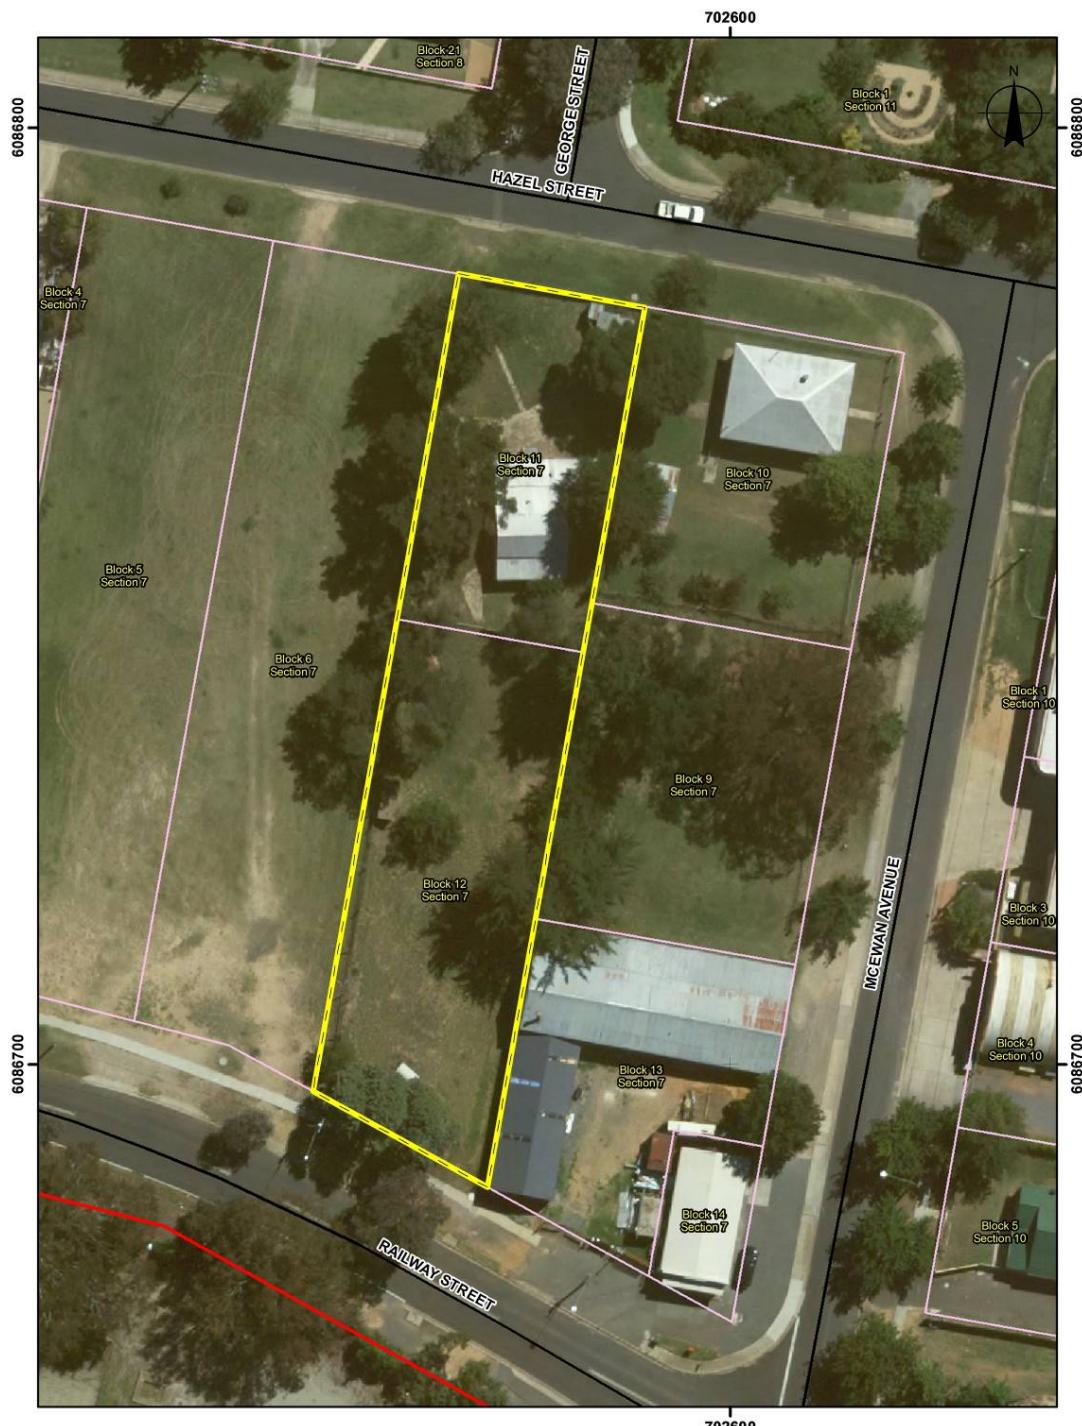
Figure 2 Robertsons' House, registration boundary.

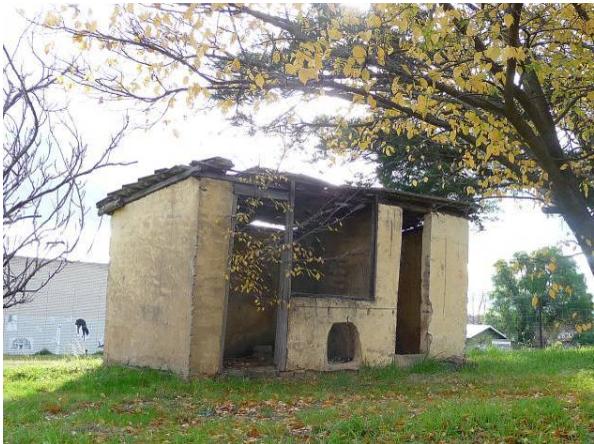
Figure 7 Fowl shed (ACT Heritage, 2014)

- The fowl shed, including the rendered concrete block walls and tiled roof.
 - The original block layout of Block 7 Section G, today Blocks 11 and 12 Section 7, including

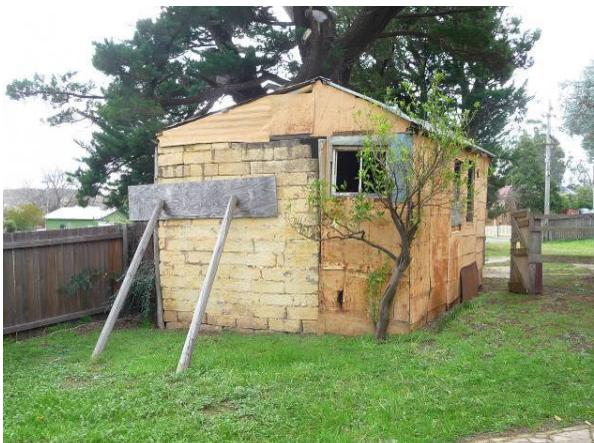
Figure 8 Southern end of western shed and laundry (ACT Heritage, 2014)

A site inspection by ACT Heritage on 11 June 2014 showed the house and grounds to be in good condition, and the outbuildings to be in a stable condition with the exception of the western shed which was in a poor condition. The house has been well maintained after the 2011 conservation works which had consolidated the external walls by replacing materials and painting existing materials which still appear to be in good condition and resistant to weathering, the new guttering and pipes are intact and working well, the interior condition has been stabilised with the flooring of bedroom 3 removed, exposing the raw earth beneath and the brick supports, the floor in bedroom 1 still has moderate movement evident when walking on it, as well as water damage to the wall, where water was entering through the ceiling. The outbuildings have been stabilised by the removal of trees affecting them and the structures repaired or strengthened where needed. The western shed is in the worst condition with the southern concrete brick wall requiring supports to stabilise it (Figure 8 - these appear to be temporary in

nature and detract from the site, although they have been in place for several years) and the western wall has lost most of its cladding with the structure becoming quite weathered and the earth floor spilling out, causing the table and wall to slump outwards. The fowl shed is in moderate condition, but the roofing is deteriorating which will expose the rest of the structure to rain. The boundary fencing installed in 2011 is in good condition and the grounds have been well maintained. The mature pine trees (*Pinus radiata*) along the boundaries are in good condition.

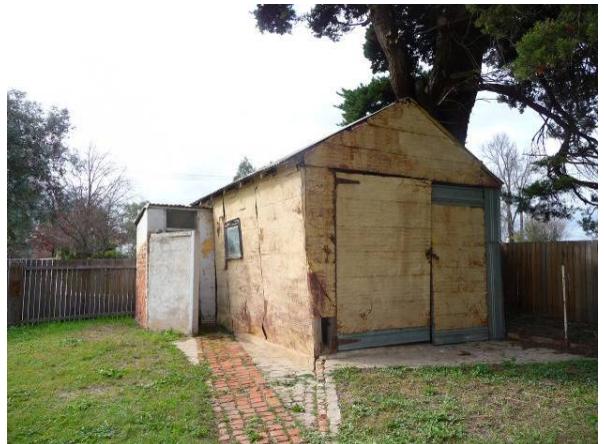
Figure 10 Northeast shed and toilet block (ACT Heritage, 2014)

- The brick chimney with the original fireplace and the late-1950s Warmray No. 2 wood-fired heater.
 - The outbuildings, including:
 - The northeast shed and attached toilet block, including the original material consisting of flattened tar drums, brick offcuts and seconds, internal shelving and work areas;

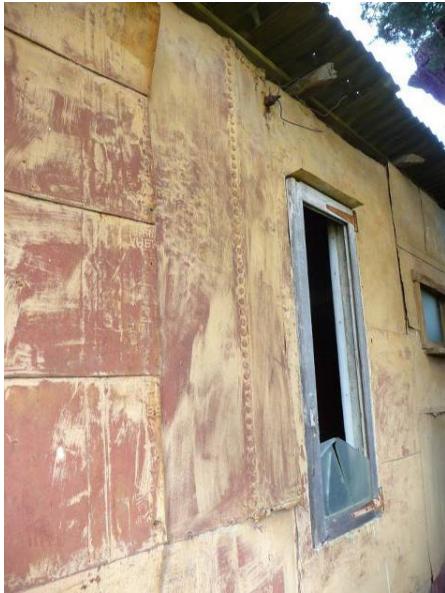
Figure 11 Tin cladding on east laundry facade (ACT Heritage, 2014)

The kerosene tins used to clad the outside and inside of the house and outbuildings come from various sources which are clustered by types in various locations. The earliest materials are located on the laundry building, originally the cookhouse, prior to the kitchen being added to the house, and workshop, and was used as a sleep-out from time to time during the depression years (Williams, 2014). There are several kerosene tins marked out with "The Texas Company. Light of the Age. Best American Kerosene" (Figure 11) and a star symbol which is an early Texaco trademark used between 1903 and 1907 (Chevron, 2014). The kerosene tins cladding the shed on the western boundary and the packing cases used for the flooring of the earliest section of the kitchen in the house were sourced from Dr Blackall who was a Queanbeyan Doctor (Williams, 2014). Also used in this structure

are what appears to be sections of a metal shipping container (Figure 11). The adjoining shed contains tins marked by "B. I. O. Co. Ltd." (Figure 12 and 13) – the British Imperial Oil Company, which operated as a subsidiary of Shell in Australia between 1905 and 1927, with the designs found at the Robertsons' House likely to correspond to the later part of this period (Shell, 2001). The tins used in the house are from the Vacuum Oil Company (Figure 13), which had a branch down the road from Robertsons' House from 1927 and were in Queanbeyan from the start of 1926.

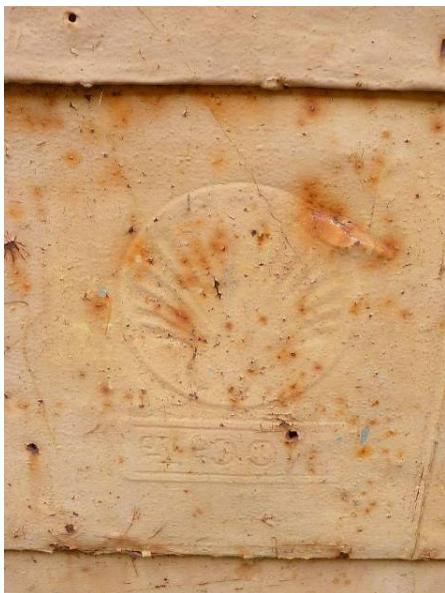
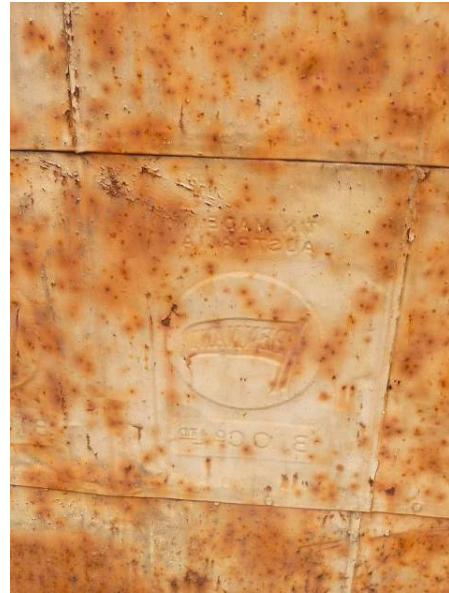
Figure 12 B.I.O. Shell kerosene tin cladding on western shed (ACT Heritage, 2014)

Figure 13 B.I.O. Pennant kerosene tin cladding on western shed (ACT Heritage, 2014)

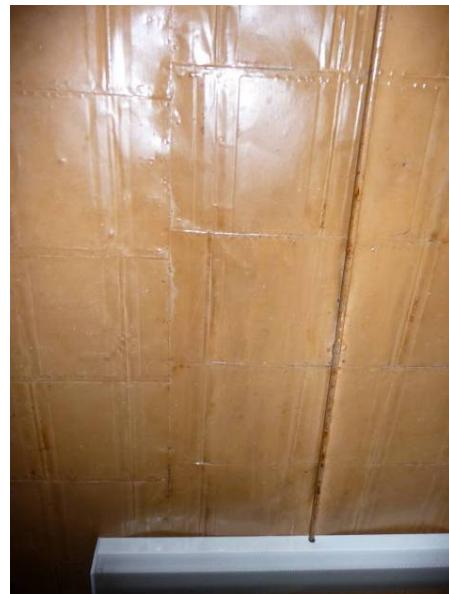
Figure 14 Vacuum Oil Company flattened kerosene tin lining on room 4/bedroom 1 ceiling (ACT Heritage, 2014)

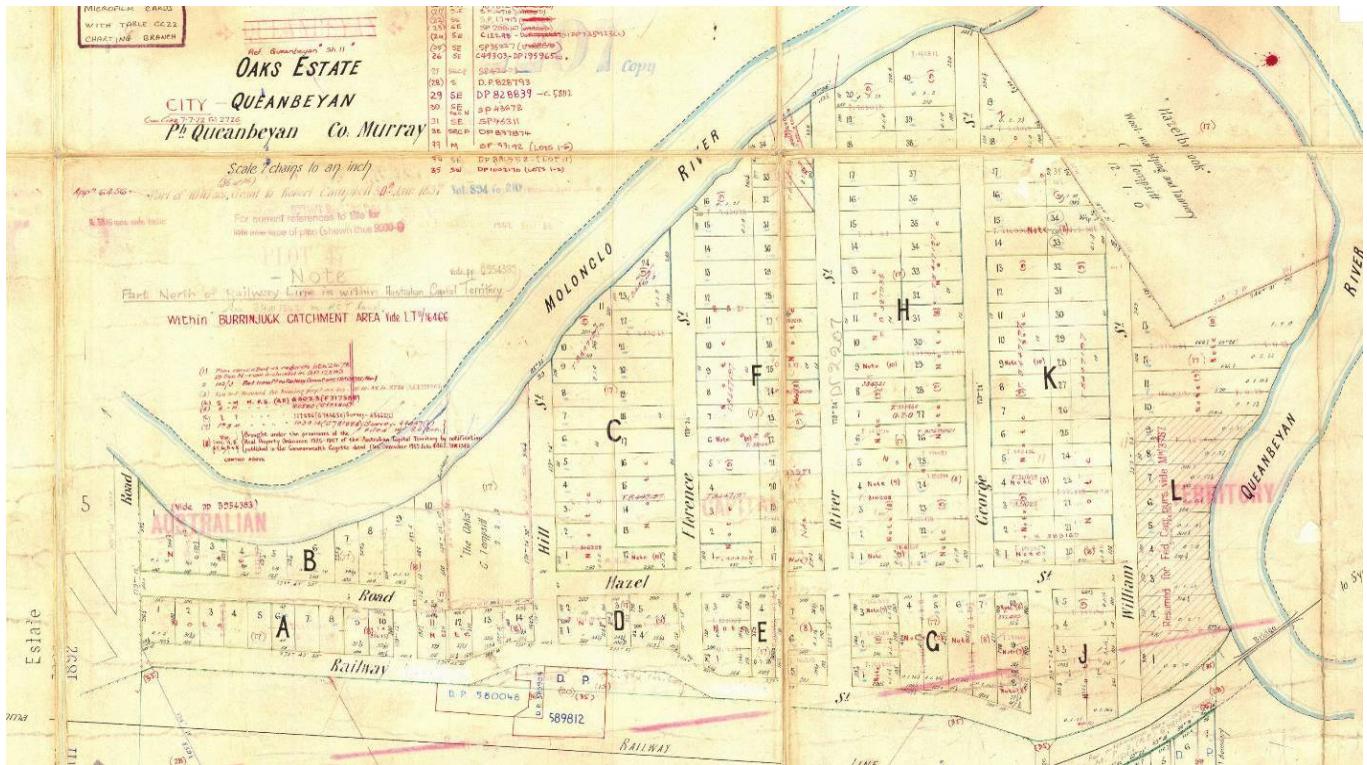
Figure 16 1888 Oaks Estate subdivision Deposited Plan 2207 (NSW Land & Property Information)

The first Robertson house was located at the bottom of George St, close to the river (the historical block layout can be seen in Figure 16 - historical block 40 Section H, today within the Hazelbrook Nursery property blocks 4 and 5 Section 14). The house was washed away in the 1891 floods after which they moved to higher ground at Blocks 8-9 Section 8 (historical Section H) on River St. On Block 9 Section 8 (H) from 1901 is where they slowly built up the family home of Weowna in stages from whatever material was available. Edward (Ned) Robertson acquired the house and land and lived there with his wife until their deaths in 1946 and 1954. Ned was a key figure in the Oaks Estate community and helped to build many of the early houses. Ned also acquired Block 20 Section 6 (F) in 1927 until 1950; Blocks 10-13 Section 8 (H) in 1927 with Blocks 11-13 transferred to William Edward Hopkins in 1957 as a partnership to run a sawmill from the property. Block 10 was retained and a brick house built there, but there is no further information on it. Ned also owned Block 26 Section 8 (H) and had a house built using bricks made by Dick Robertson. It was sold in 1940. Ned had houses built on Block 7 Section 8 (H) and Block 22 Section 6 (F) from bricks made by Dick Robertson at his house on Block 11 Section 7 (previously Block 7 Section G). The roof being a joint venture between Dick and Tom. The builder was Tom Rickman who married Jessie Robertson and the couple lived in the house until 1957. The other house (B7) was occupied by Ivy Robertson who had married Sydney Goggin, who were living with Ned and family while it was being built. (Williams, 1997)
