Heritage (Decision about Provisional Registration of the 'Expansion' Mosaic Mural Wall, Braddon) Notice 2012

HERITAGE REGISTER (Provisional Registration Details)

'Expansion' Mosaic Mural Wall, Braddon

(Part) Block 1 Section 8 Braddon, ACT

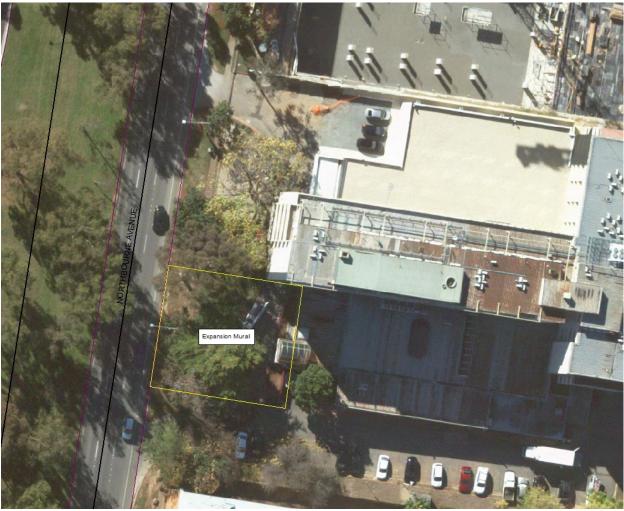
Figure 1. Location of the Mural and open character landscape area between the Mural and Northbourne Avenue, at the Rex Hotel, Northbourne Avenue. Boundary is indicated by yellow line. Map is not to scale.

The 'Expansion' Mosaic Mural Wall is situated on the southern side of the main entrance to the Canberra Rex Hotel (2012) and is set approximately 10m back from the main road (Figures 1 and 2). The wall faces Northbourne Avenue and while it is partially concealed by vegetation, including trees, it can be viewed directly in front of the hotel from the road and pathway as one approaches the city travelling south (Figures 2 and 3). The Mural is constructed from hand-cut, irregular shaped glass, vitreous and porcelain tiles and measures 2.3m in height and 12.3m in length.

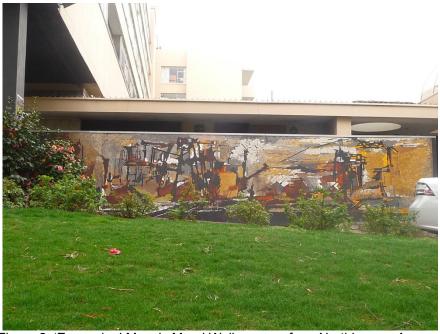
Figure 2. 'Expansion' Mosaic Mural Wall as seen from Northbourne Avenue (ACT Heritage Unit, Sep 2012).

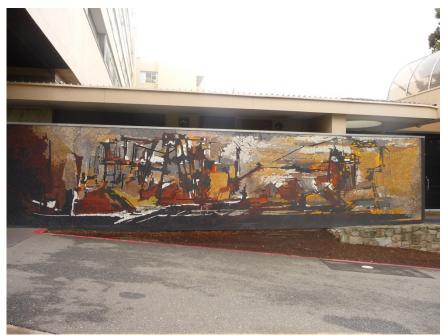
Figure 3. 'Expansion' Mosaic Mural Wall as seen from the driveway of the Rex Hotel (ACT Heritage Unit, Sep 2012).

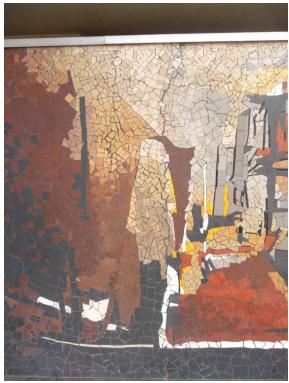
Major structural damage was observed that included three large vertical structural cracks and one hairline crack across the Mural. In 2009, urgent stabilisation works were recommended to prevent further loss of tiles and extension of drummy areas. In addition, minor structural problems were also observed including minor loss of grout between the tiles across the extent of the Mural, with higher loss in areas of structural cracking, cracked tiles which date from time of manufacture, areas of drummy tiles and areas of chipped and impact damaged tiles. Also, it was observed that the surface of the Mural exhibited applied and incised graffiti, general dirt and cobwebs, extensive paint splatter from repainting of the building and extensive mould and algae staining which was particularly heavy towards the southern end of the Mural.

Figure 4. Repaired Structural Crack 1, situated in sections 5 and 6 (ACT Heritage Unit, Sep 2012).

In 2010, the Mural was restored by Conservation Works Pty Ltd. The treatment comprised the following; the two large cracks were repaired and sealed, its surface was clean, washed with a non-iconic detergent and tap water; the top capping was stabilised, drummy tiles were consolidated and missing tiles,

replaced, a cement based black sand grout was used to repair mortar loss, and a tree growing towards the centre of the Mural was removed (Mitchell 2010). In addition, during the treatment it was observed that the footings were 'partially unsupported', as the wall is constructed on a slab with a cantilevered edge; however, this is not considered to be the cause of the structural issues. A large void was also filled in with a "standard brickies mortar" mix (Mitchell 2010). These repairs were funded by a grant from the ACT Heritage Unit.

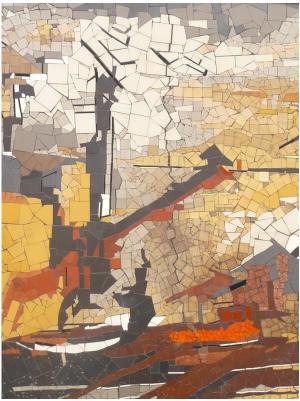
Figure 5. Repaired structural crack of sections 11 and 12 (ACT Heritage Unit, Sep 2012).

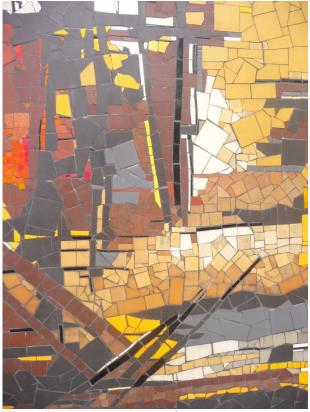
The Mural's construction involved the preparation of a full sized painted cartoon onto which Lewers glued each hand-cut irregular shaped glass, vitreous or porcelain tile face down. The colours and tones were selected in response to the hotel's external colour scheme of yellow, grey and black, to which the artist added earthy reds, white and brown (Figures 4, 5 and 6). The Mural was laid in sections on site under the artist's supervision.

Figure 6. Close up of the Mural, illustrating its abstract form and stark colour combinations of bright and earthy hues, indicative of Margo Lewer's style (ACT Heritage Unit, Sep 2012).
